**Assessment Report on the Results of Metro
North Advance Archaeological Test Trenching,
Testing Area 10, Ballystruan townland, Co.
Dublin,
RPA ref: (MN103 and MN104) Metro North
Alignment to Construction Compound 8 (South
Portal Tunnel)**

Excavation Licence Number: 09E478
Director: William O. Frazer
Report Author: William O. Frazer
Project Code: RPMN08
Client: Railway Procurement Agency RPA 7120_5
Townland: Ballystruan
Ordnance Datum: 60 m
NGR: 316376/242056

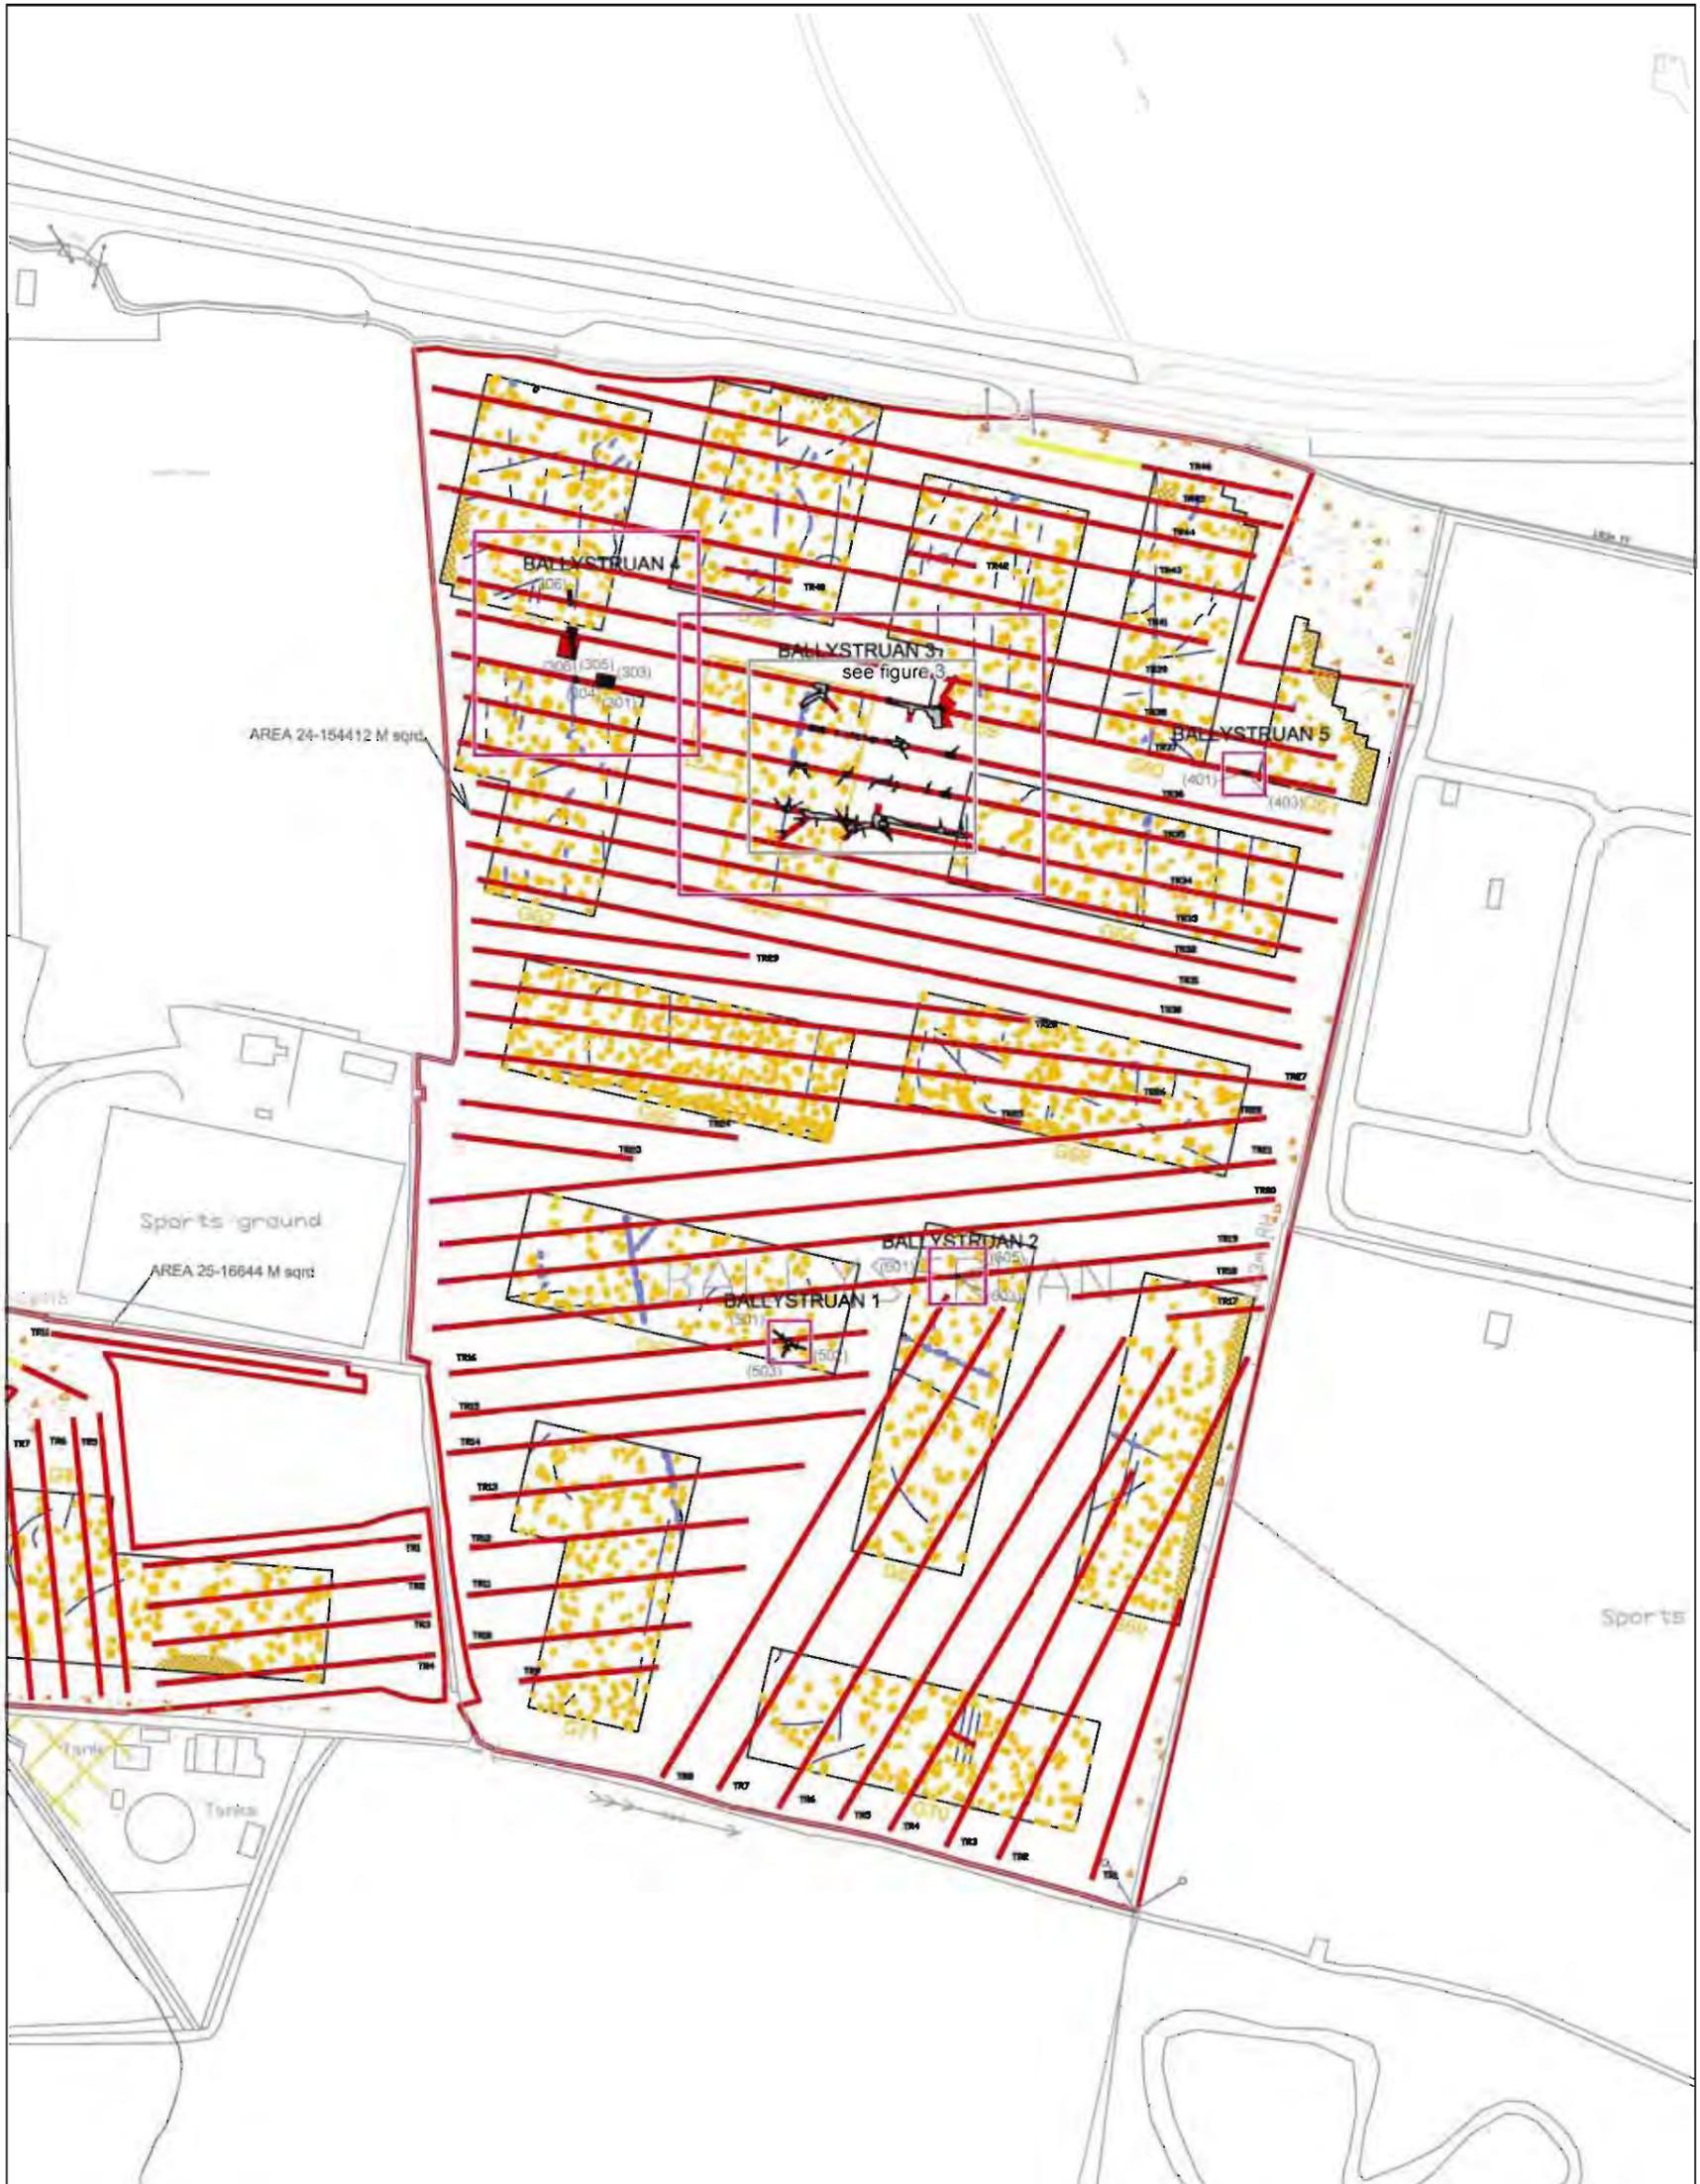
Figure 2 - Advance Archaeological Test Trenching of Metro North: Testing Area 10, Ballystruan townland, Co. Dublin, RPA ref: (MN103/ MN104) Metro North Alignment to Construction Compound 8 (South Portal Tunnel). Trench layout and location of identified archaeology including geophysical survey results.

Five archaeological sites were identified within the field (Figure. 2). These included (from south to north): a pit containing burnt mound material of probable Bronze Age date (*c.*2200–500BC) (Ballystruan 1; Plates 2–3); a cluster of probable cremation

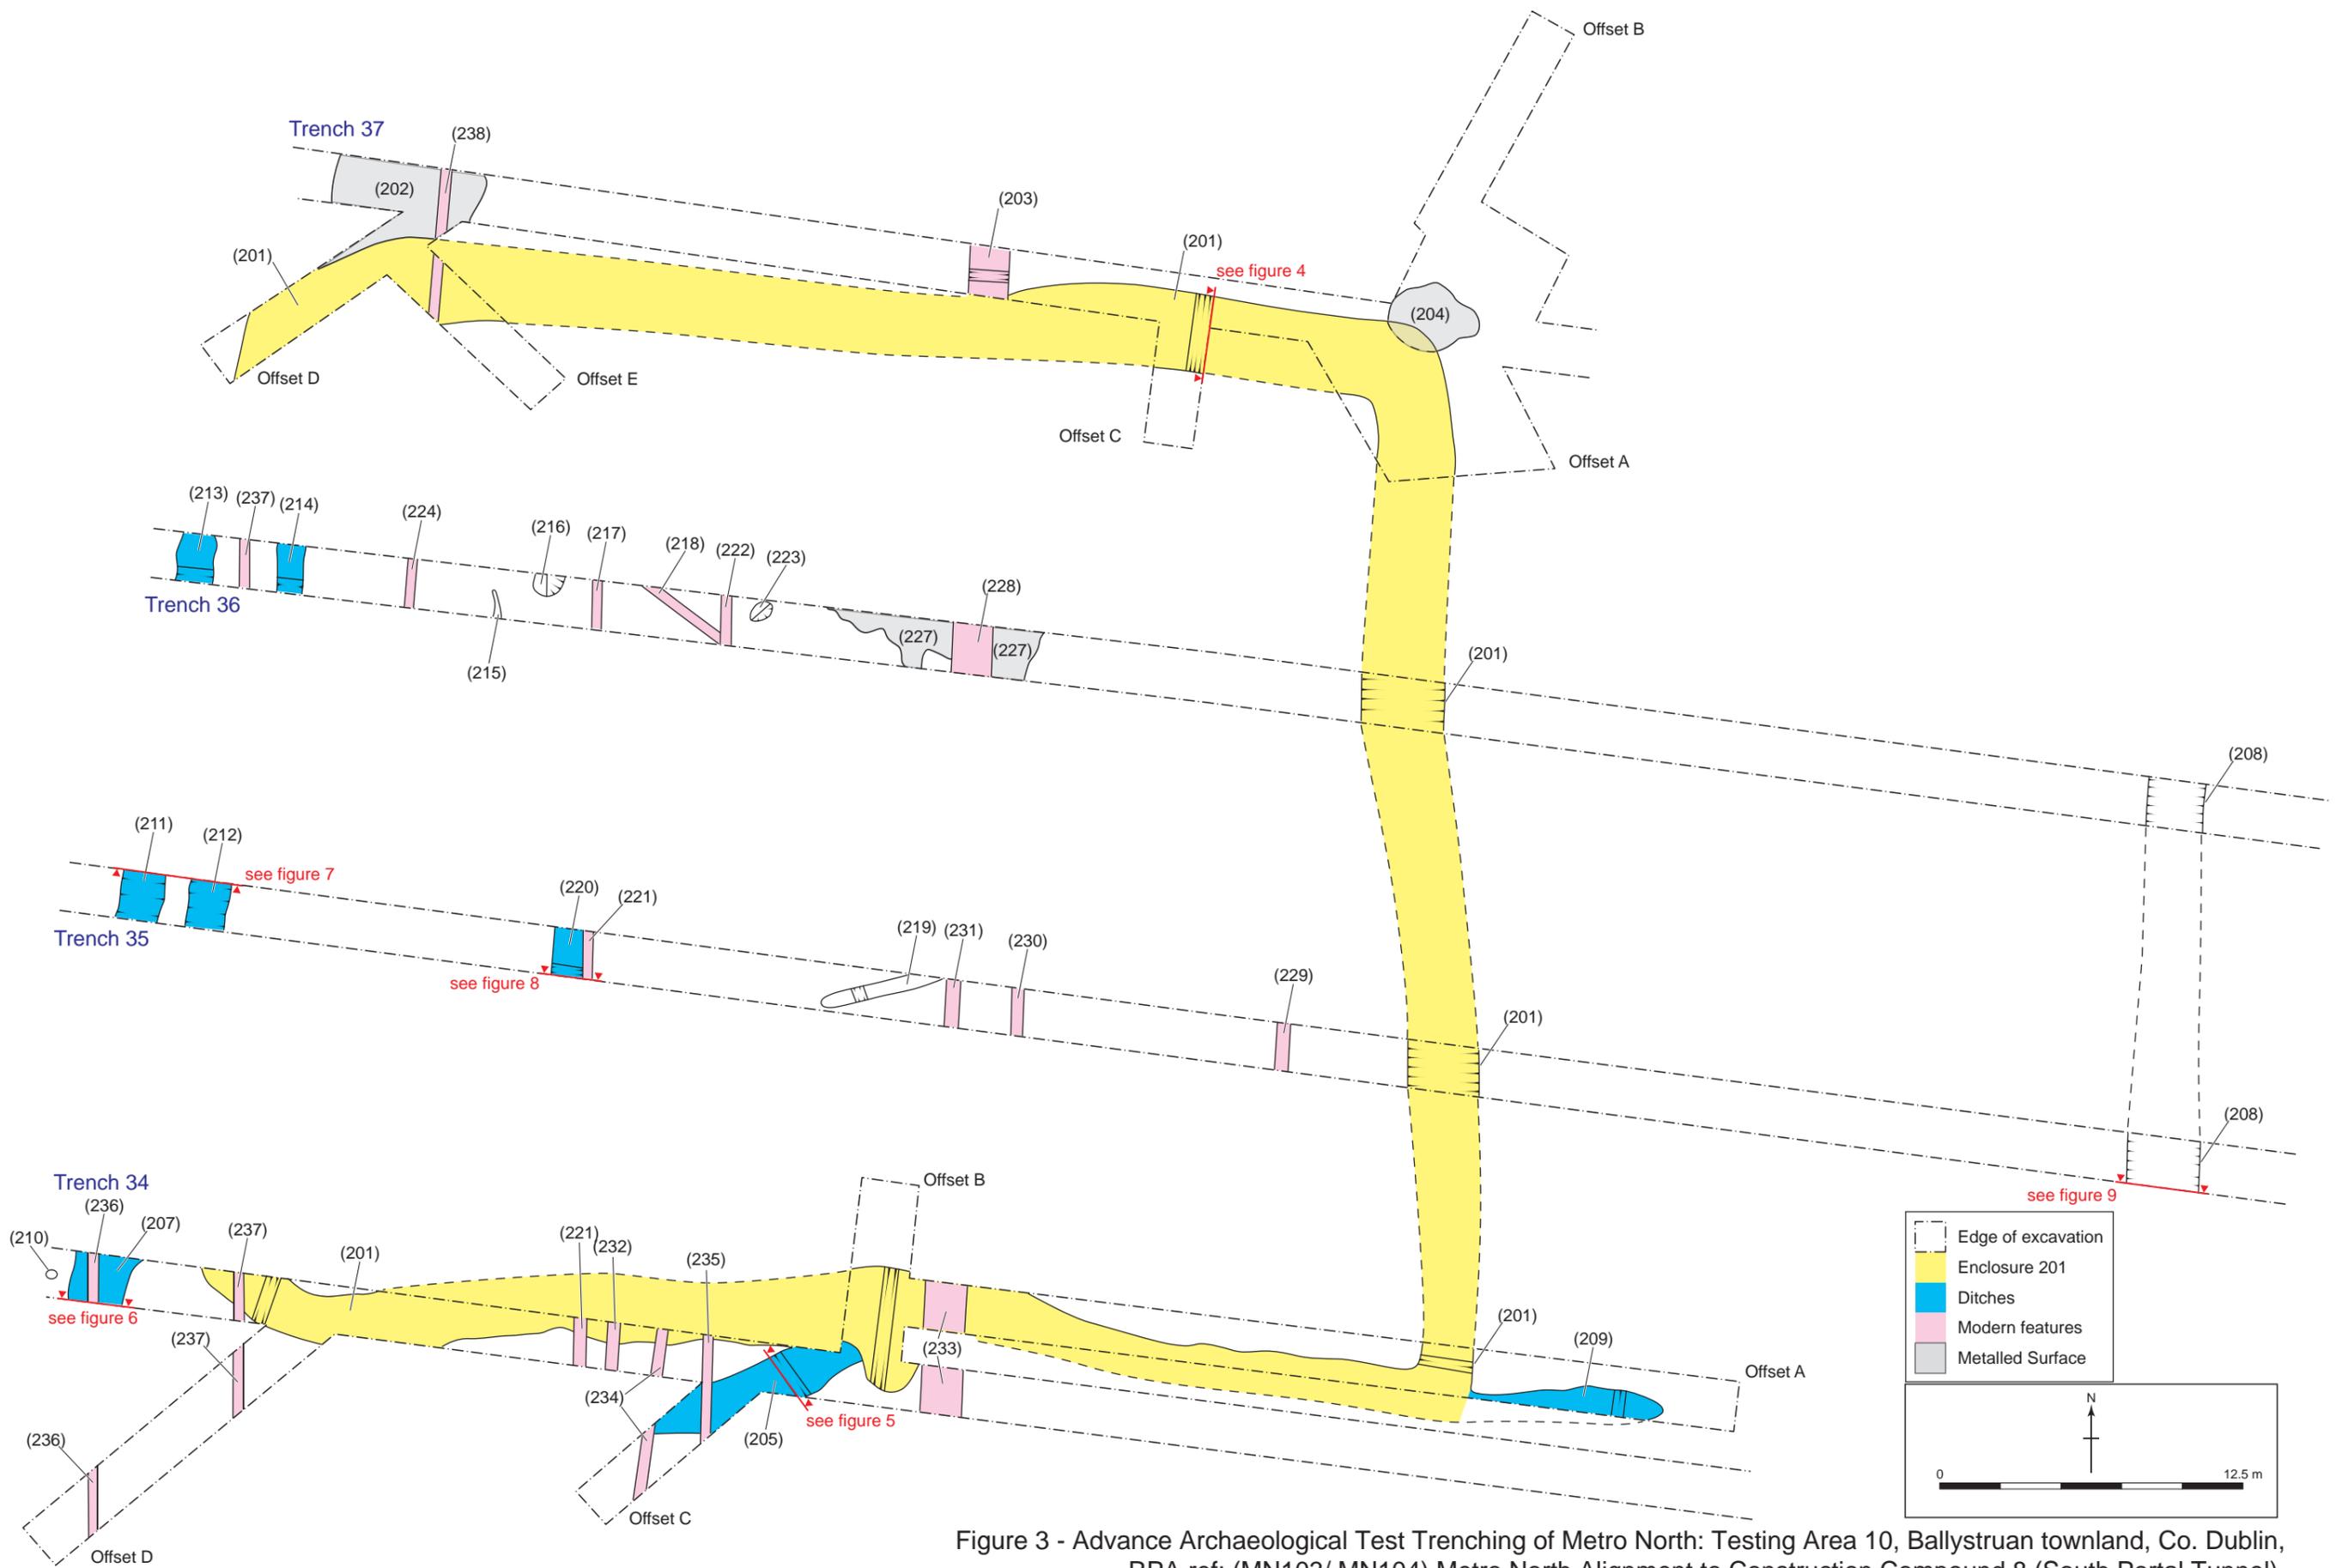
Figure 3 - Advance Archaeological Test Trenching of Metro North: Testing Area 10, Ballystraur townland, Co. Dublin, RPA ref: (MN103/ MN104) Metro North Alignment to Construction Compound 8 (South Portal Tunnel). Plan of Ballystraur 3 sub-rectangular enclosure site.

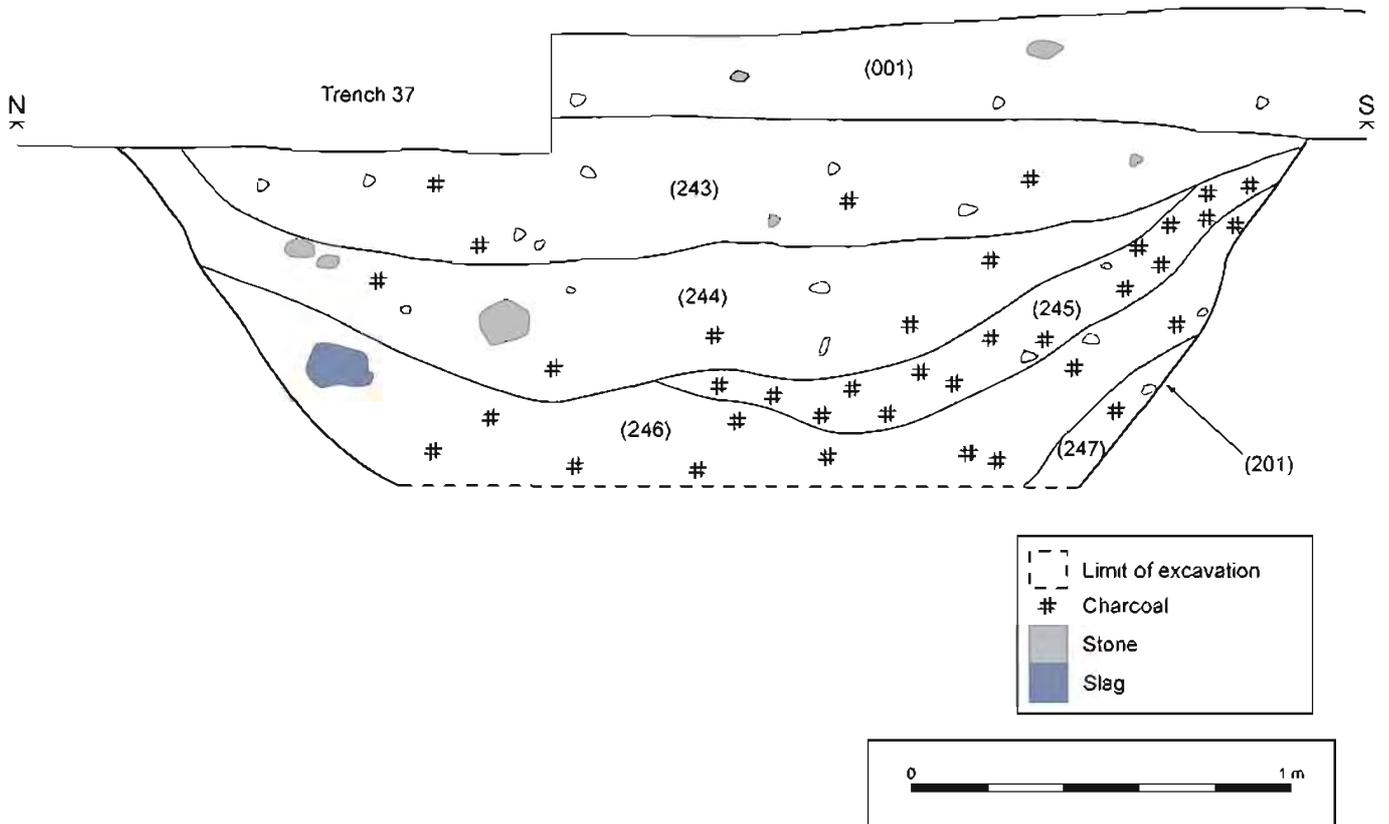
Figure 4 - Advance Archaeological Test Trenching of Metro North: Testing Area 10, Ballystruan townland, Co. Dublin, RPA ref: (MN103/ MN104) Metro North Alignment to Construction Compound 8 (South Portal Tunnel). West-facing section of north side of Ballystruan 3 enclosure ditch (201).

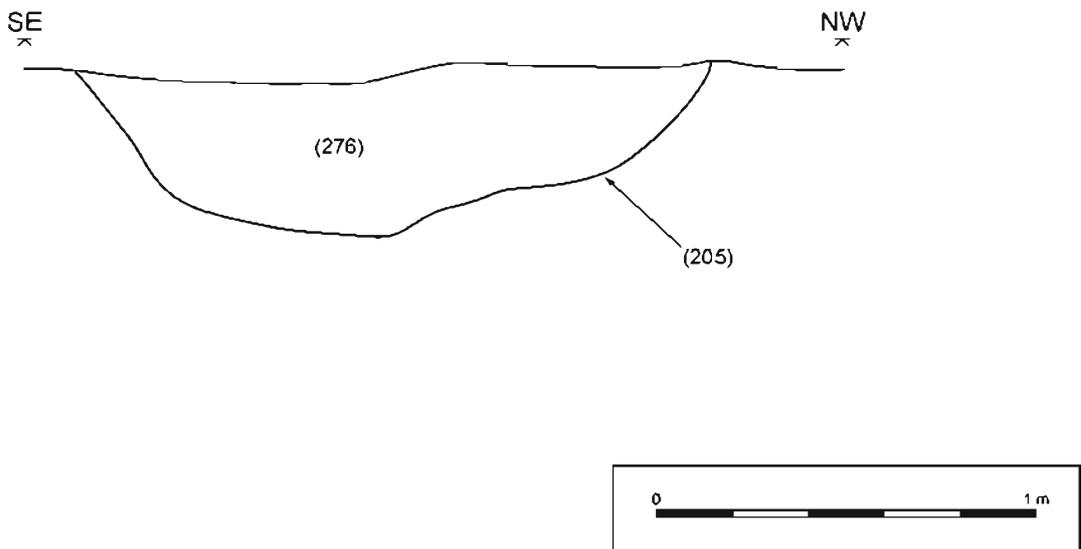
Figure 5 - Advance Archaeological Test Trenching of Metro North: Testing Area 10, Ballystruan townland, Co. Dublin, RPA ref: (MN103/ MN104) Metro North Alignment to Construction Compound 8 (South Portal Tunnel). Northeast-facing section of Ballystruan 3 ditch (205).

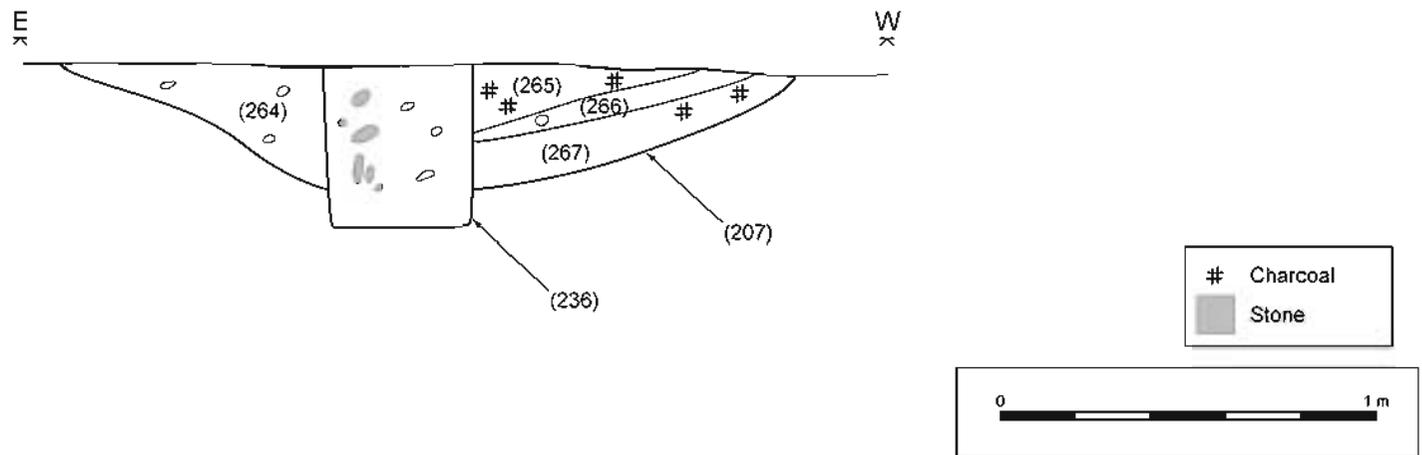
Figure 6 - Advance Archaeological Test Trenching of Metro North: Testing Area 10, Ballystraun townland, Co. Dublin, RPA ref: (MN103/ MN104) Metro North Alignment to Construction Compound 8 (South Portal Tunnel). North-facing section of Ballystraun 3 ditch (207).

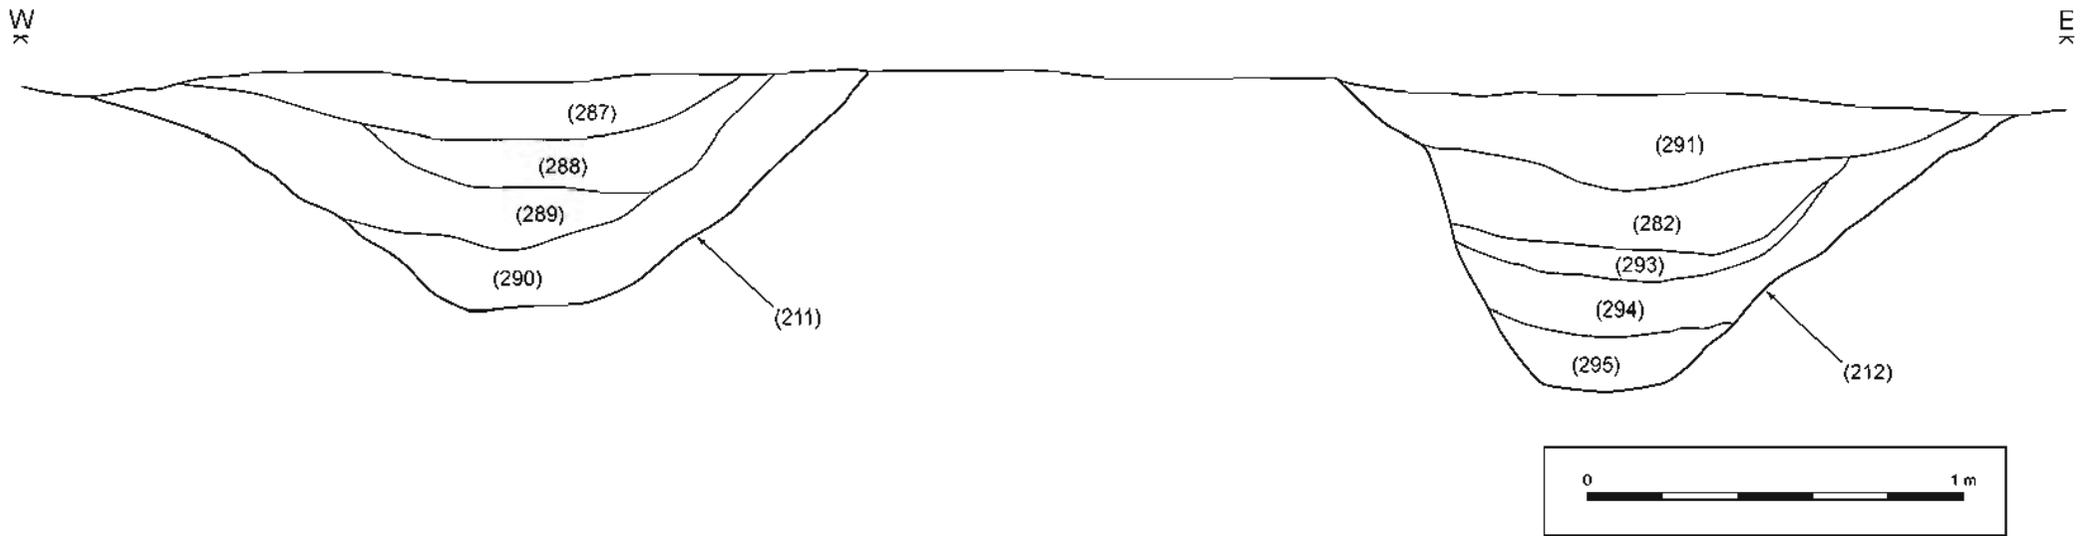
Figure 7 - Advance Archaeological Test Trenching of Metro North: Testing Area 10, Ballystraun townland, Co. Dublin, RPA ref: (MN103/ MN104) Metro North Alignment to Construction Compound 8 (South Portal Tunnel). South-facing section across west of Ballystraun 3 double ditches (211) (outer) and (212) (inner).

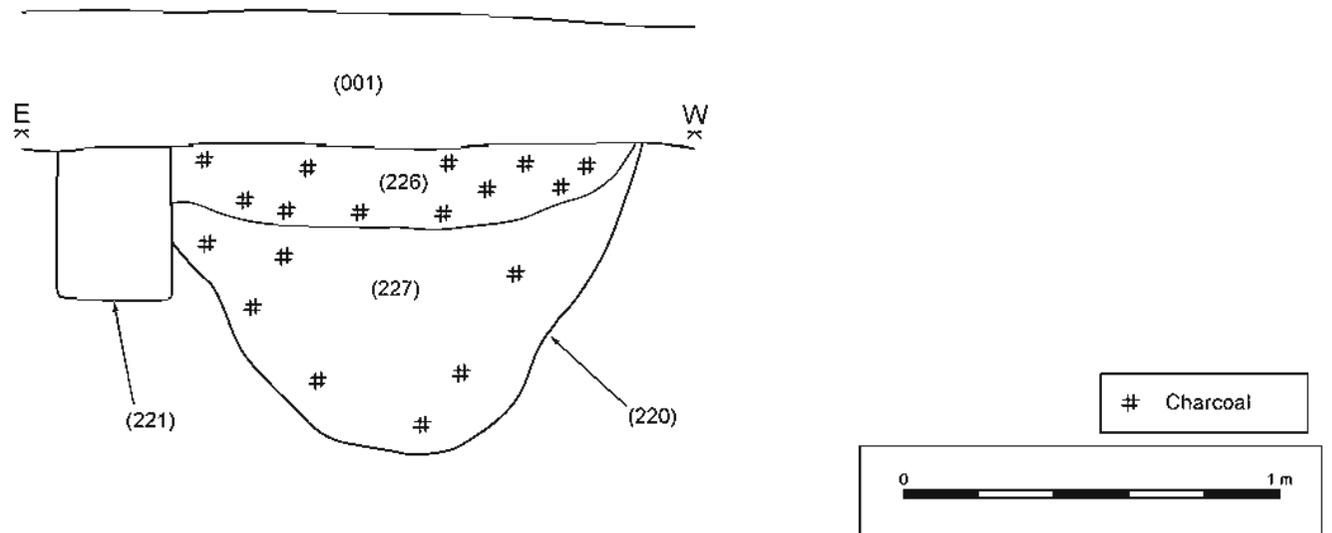
Figure 8 - Advance Archaeological Test Trenching of Metro North: Testing Area 10, Ballystruan townland, Co. Dublin, RPA ref: (MN103/ MN104) Metro North Alignment to Construction Compound 8 (South Portal Tunnel). North-facing section of interior ditch (220) within Ballystraun 3 enclosure.

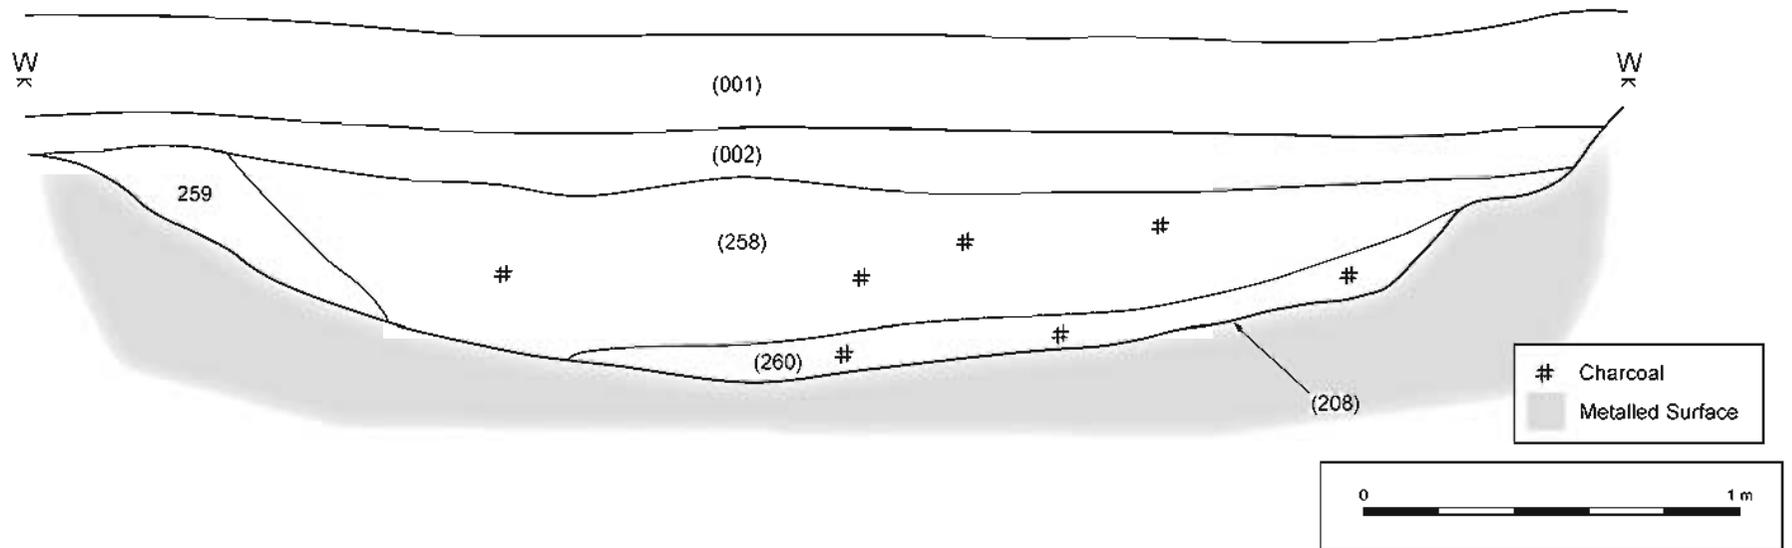
Figure 9 - Advance Archaeological Test Trenching of Metro North: Testing Area 10, Ballystruan townland, Co. Dublin, RPA ref: (MN103/ MN104) Metro North Alignment to Construction Compound 8 (South Portal Tunnel). North-facing section of metallated hollow way (208) to east of Ballystraun 3 enclosure.

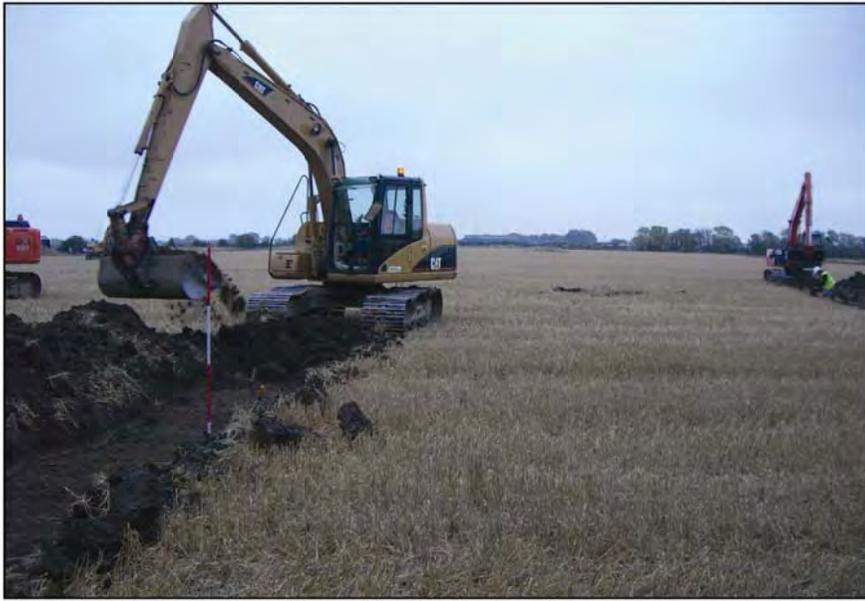
Plate 1 - General view of trenching in Testing Area 10.

The advance archaeological testing for Testing Area 10 (09E478) was carried out on the 24 September–1 October 2009 by William O. Frazer. Forty-six test trenches were excavated in a single large field, Sub-area 24 (Figure 2; Plate 1). A total of 9314.72 linear metres were excavated, comprising 12.06% of the testing area.

A total of 46 test trenches were mechanically excavated in a single large field (Sub-area 24) at Testing Area 10 (Figure 2; Plate 1), totalling approximately 18,629.44 m² of the testing area space of 154,412 m² (i.e. 12.06% of the testing area).

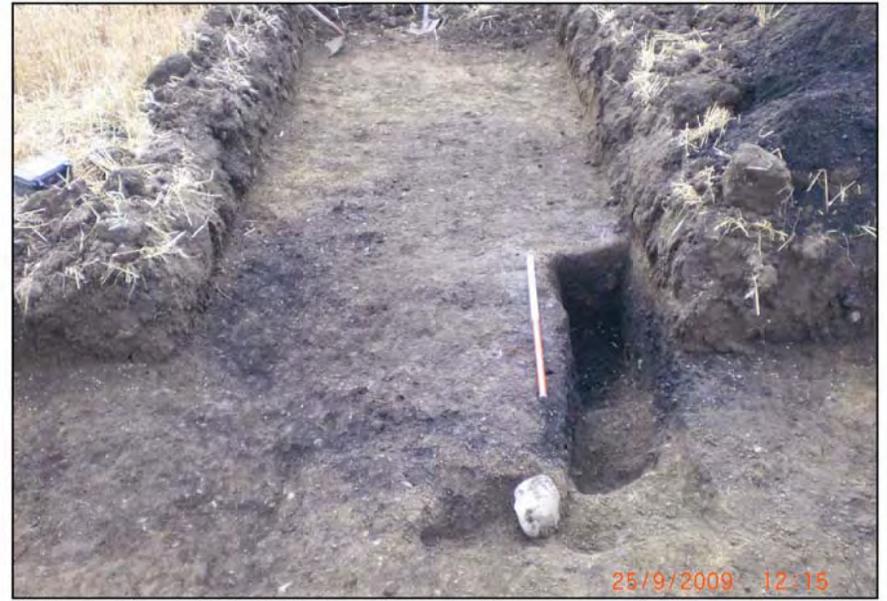
Ballystruan 1 consisted of a kidney-shaped pit (501) containing burnt mound material, provisionally of Bronze Age date (c.2200–500BC). It was identified in Test Trench 16, approximately 26–31 m from the west end of that trench and measured 3.5 m northeast/southwest by 2.5 m by 0.50+ m deep (Figure 3; Plates 2–3). A faint 1.3 m-long shallow northeast linear feature was identified extending from its northwestern side, however this is likely to be the remains of a plough furrow or potato drill.

The pit itself had gradually sloping, stepped sides and a sharp upper break of slope that was at least 0.50 m deep. It was filled by outer fill (502), which was present around the perimeter of the feature and extending into the linear projection. This consisted of dark grey clay silt with frequent inclusions of small to medium-sized sub-rounded stones. It measured 0.3–0.8 m wide in plan and achieved a depth of 0.15 m (0.10 m in the shallow, concave ditch). The central fill (503) consisted of loose dark black clay with frequent charcoal flecks, some 30% of which was composed of heat-shattered small to medium-sized sub-rounded stones. This fill achieved a depth of 0.50 m, although it was not bottomed. On the basis of their stratigraphic relationship and similarity, the distinction between these fills is likely to have arisen as a consequence of site transformation processes (water leaching, weathering) rather than as a result of different depositional events.

The pit (501) appeared to be in complete isolation, with no evidence of an associated burnt mound. It is possible that such a mound has been destroyed through centuries of agricultural activity, or that all activities taking place were conducted within the cut itself.

Plate 2 - View of pit (501), Test Trench 16, Sub-area 24 (Ballystruan 1), facing south.

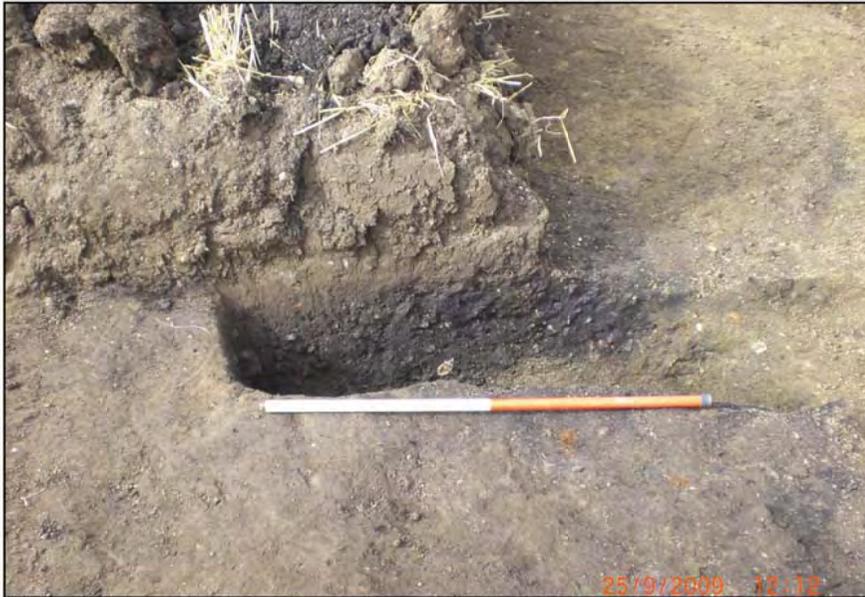
Plate 3 - View of pit (501), Test Trench 16, Sub-area 24 (Ballystruan 1), facing west

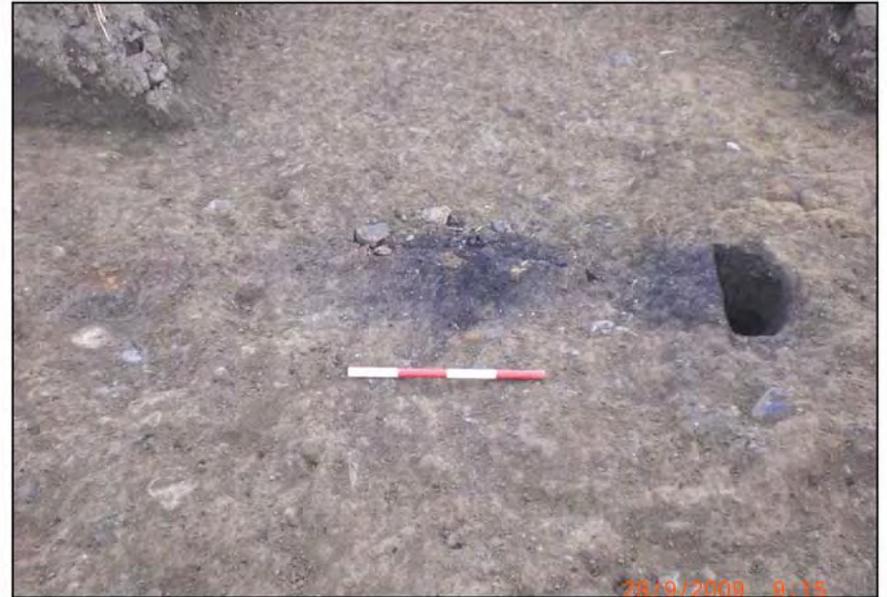
Ballystruan 2 consisted of three approximately east/west aligned pits (605), (603) and (601), from east to west), all between 0.25-0.50 m across. Each contained an upper fill (606), (604) and (602), respectively of moderately-compact–loose dark brown black silt clay/clay silt with occasional tiny–small angular stones and charcoal flecks. Occasional burnt bone was also identified in fills (606) and (604). Pit (605) was half-

sectioned to reveal a vertical-sided cut with sharp upper breaks of slope, gradual basal breaks of slope and a concave base 0.35 m deep. The lower 0.20 m of the pit contained a basal fill (607) of loosely-compacted mottled black/brown/orange clay.

Plate 4 - View of possible cremation burial pits (601), (603), (605), Test Trench 19, Sub-area 24 (Ballystruan 2), facing north.

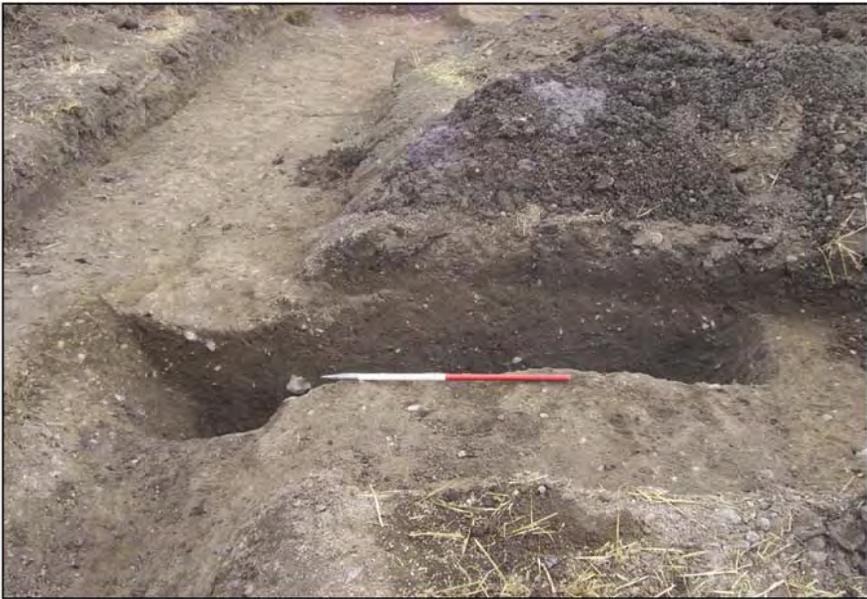
Plate 5 - Section of sub-rectangular enclosure ditch (201), Test Trench 37, Sub-area 24 (Ballystruan 3), facing east.

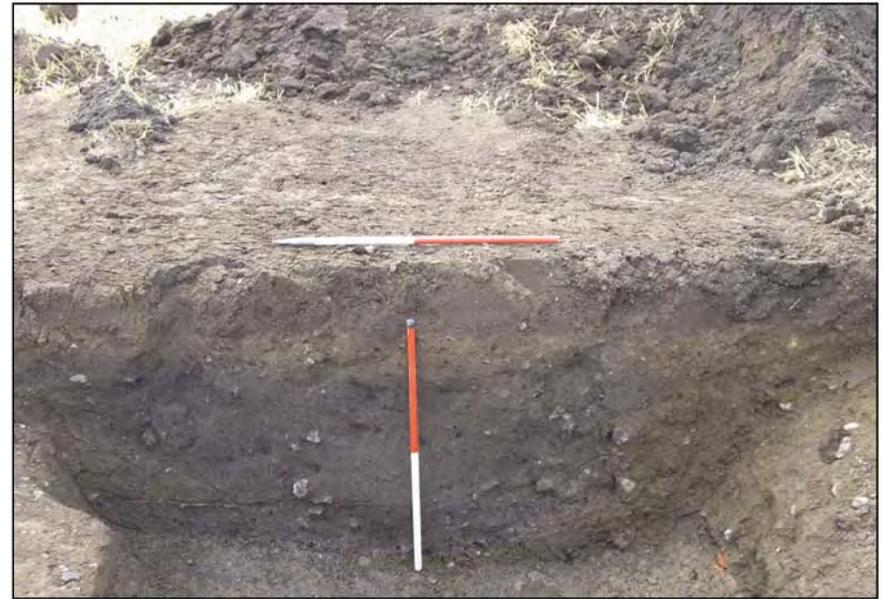
Plate 6 - Section of sub-rectangular enclosure ditch (201), Test Trench 36, Sub-area 24 (Ballystruan 3), facing south.

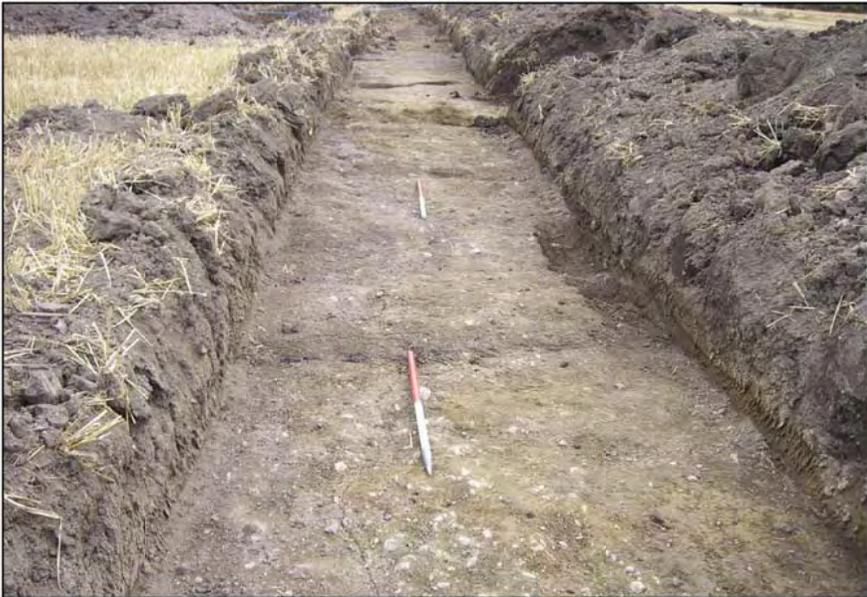
Plate 7 - View of sub-rectangular enclosure ditch (201), Test Trench 34, Sub-area 24 (Ballystruan 3), facing east.

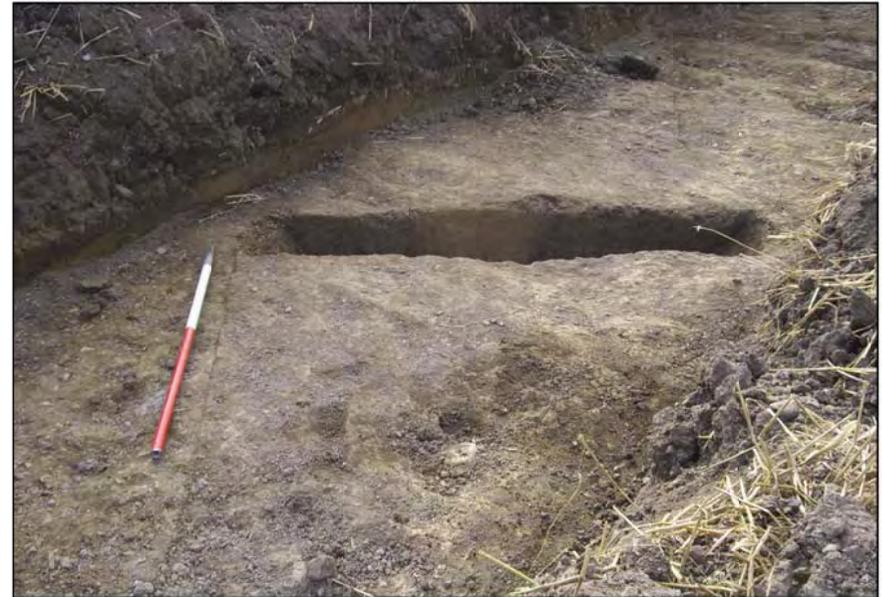
Plate 8 - Section of sub-rectangular ditch (205), Test Trench 34, Sub-area 24 (Ballystruan 3), facing southwest.

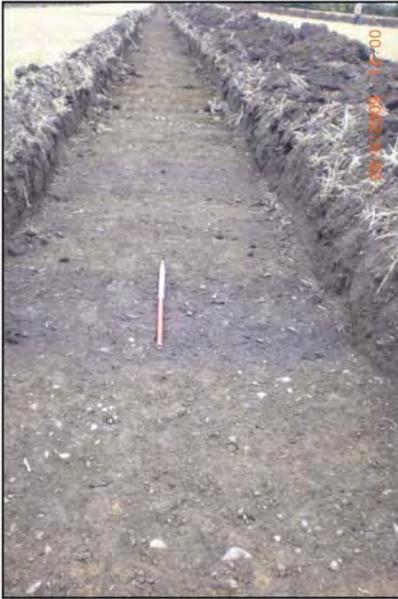
Plate 9 - Pre-excavation view of double enclosure ditches (211), (212), Test Trench 35, Sub-area 24 (Ballystruan 3), facing east.

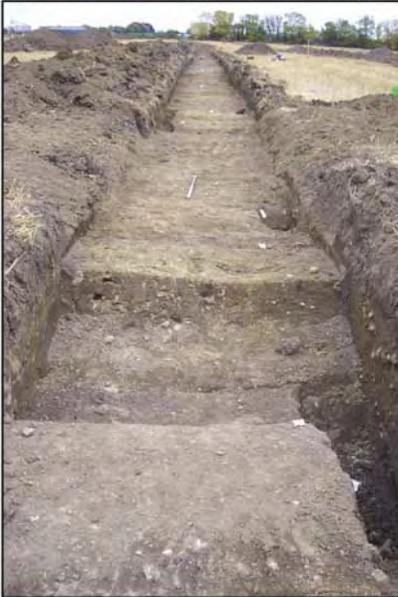
Plate 11 - General view of Test Trench 36, Sub-area 24, facing east.

- Plate 11:** General view of Test Trench 36, Sub-area 24, facing east
- Plate 12:** Detail of metalled surface (202), Test Trench 37, Sub-area 24 (Ballystruan 3), facing north

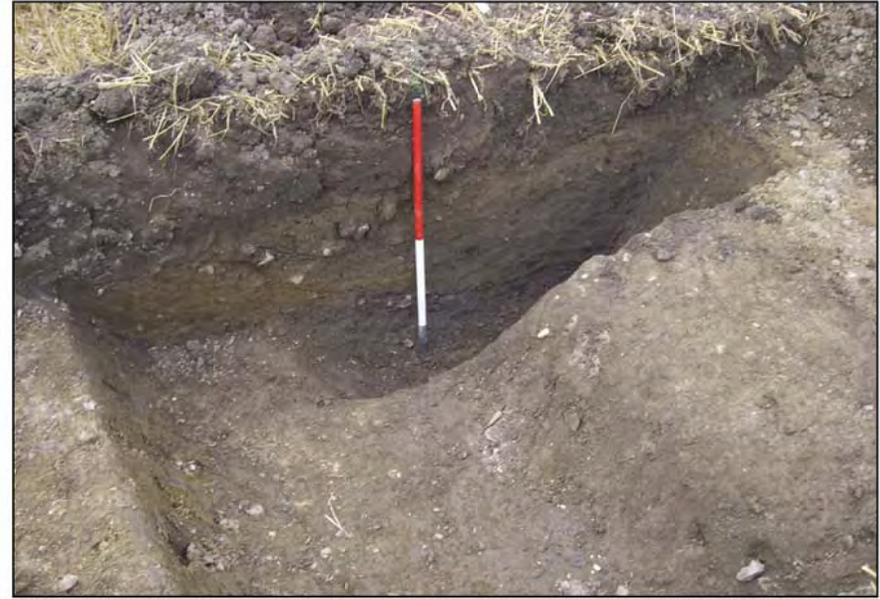
Plate 10 - Mid-excavation view of enclosure ditch (213), Test Trench 35, Sub-area 24 (Ballystruan 3), facing south-southwest.

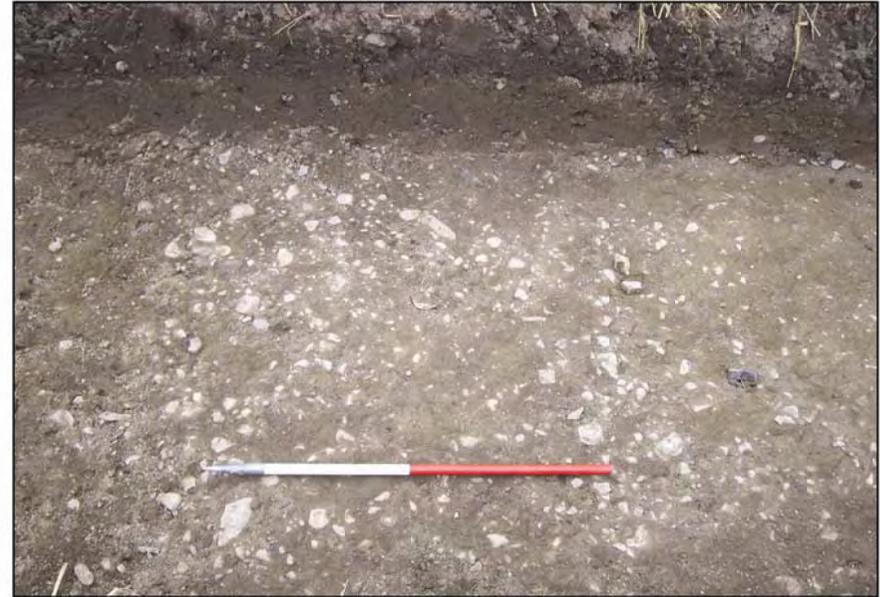
Plate 12 - Detail of metallated surface (202), Test Trench 37, Sub-area 24, facing north.

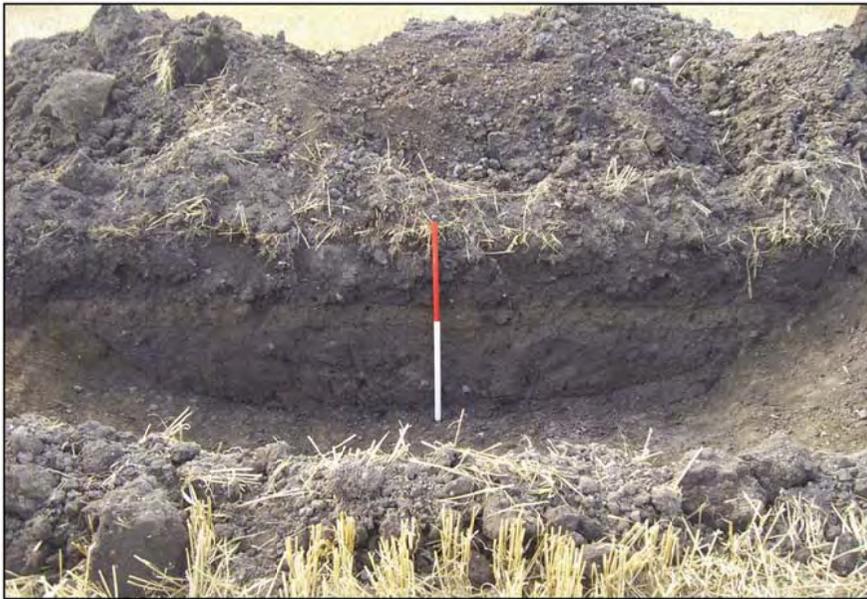
Plate 13 - Mid-excavation of hollow way (208), Test Trench 36, Sub-area 24 (Ballystruan 3), facing north (see Figure 9).

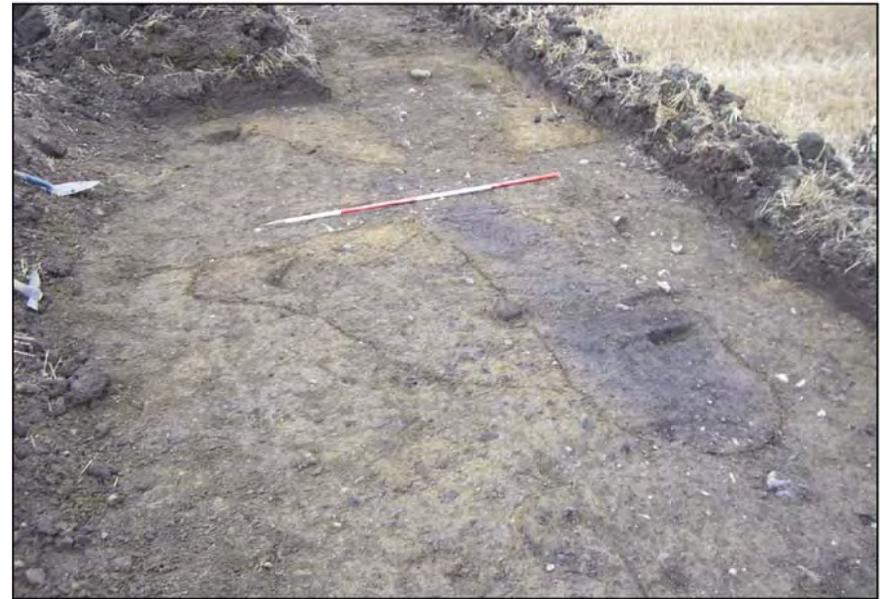
Plate 14 - View of curvilinear ditch, pits (303), (305), (301), (304) Test Trench 36, Sub-area 24 (Ballystruan 4), facing southeast.

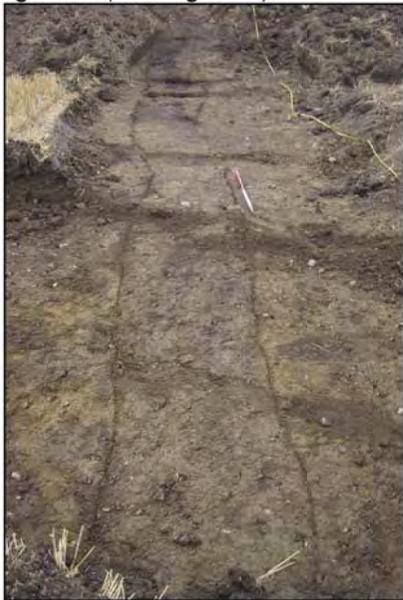
The linear potato drill measured contained charcoal-rich fills along a length of less than 40 m, and two sections across it reveal a broad u-shaped profile 0.22–0.50 m deep, with gradual breaks of slope and a concave base. Three fills were identified (312), (313), (314), as well as a possible recut (307) into the basal fill that has since been considered unlikely. The basal fill (314) was light yellow brown silt clay, the middle fill (313) was dark grey silt clay with frequent fragments of burnt clay and occasional charcoal inclusions, and the upper fill (312) was dark brown grey silt clay with frequent charcoal inclusions. All three fills tipped in from the east-northeast and were discernible as striped within the surface of the ditch.

Plate 15 - View of charcoal-rich fill within possible potato drill (306), Test Trench 37, Sub-area 24 (Ballystruan 4), facing north-northwest.

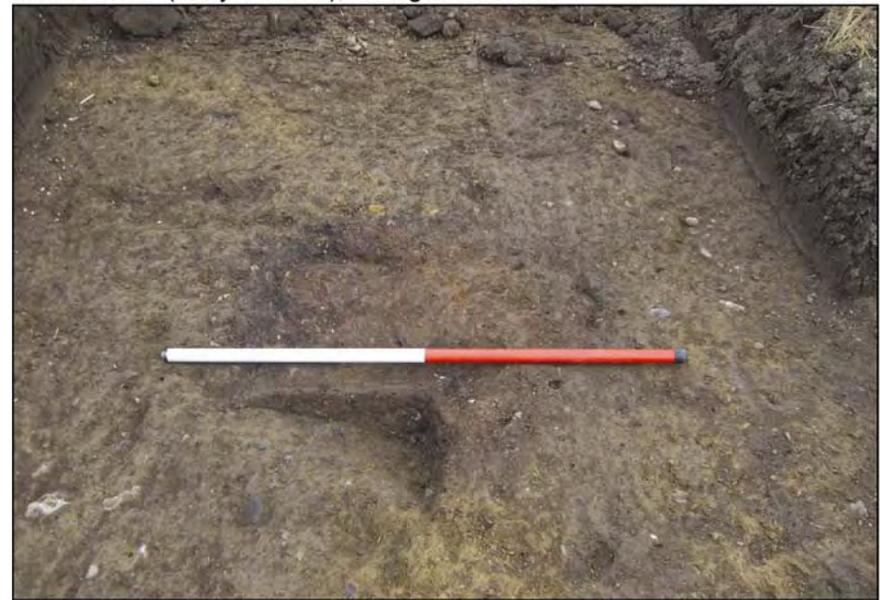
Ballystruan 5 consisted of a single 0.80 m-diameter firepit (401) containing a single fill (402) of dark grey clay silt mottled with reddish burnt clay, with frequent inclusions of medium-sized heat shattered stones and charcoal flecks and occasional tiny–small stones and shell fragments. The pit was quarter-sectioned to reveal a cut with gentle breaks of slope, concave sides and a flattish base, 0.11 m deep. A north/south post-medieval–modern furrow (403), with fill (404) truncated the west side of pit (401).

Plate 16 - View of firepit (401), Test Trench 37, Sub-area 24 (Ballystruan 5), facing north.
