# Assessment Report on Results of Metro North Dardistown Depot Archaeological Test Trenching, Ballymun and Ballystruan townlands, Co. Dublin

Excavation Licence Number: 11E039 Director: James Kyle and Dave Bayley Report Author: Dave Bayley and James Kyle Project Code: J2616 Client: Railway Procurement Agency RPA MN\_7120\_12 Townland: Ballymun and Ballystruan Ordnance Datum: 65m NGR: 315865 / 242028

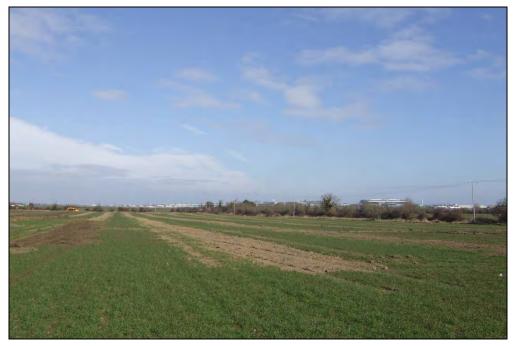
Plate 1: Test Area 1, after trenching, facing north

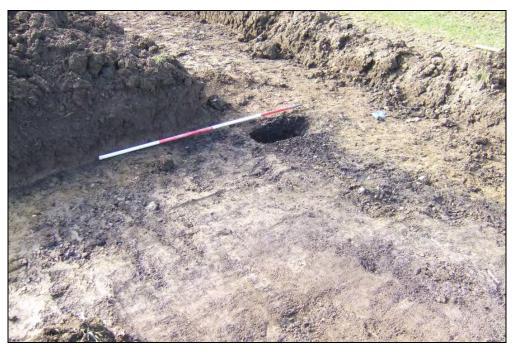
One site of archaeological significance, a burnt mound designated as Ballymun 3, was identified in Test Area A1 (Plates 2 and 3). Ballymun 3 was located *c*. 110m from the south of TT 8 (see below for detail).

Plate 2: Ballymun 3 in TT8, TA A1, facing southwest

- In order to mitigate the direct impact on Ballymun 3 it is recommended that a minimum buffer zone of 20m is established around the limits of Ballymun 3 for archaeological excavation to ensure that all the features and anomalies are archaeologically investigated. It should be noted that during excavation previously unknown archaeological features may be identified which will require expansion of the excavation areas to ensure this 20m buffer zone is maintained.
- Recording methods: in accordance with best practice and the DoEHLG Policy and Guidelines on Archaeological Excavation.
- Sampling strategy: Sample fills from the burnt mound for archaeobotanical analysis and C14 dating.
- Proposed resources: 1 IAC director management; 1 supervisor; 4 site assistants; 1 surveyor; relevant plant (as required); relevant specialists (as required).
- Time-scale for completion: 2 weeks.

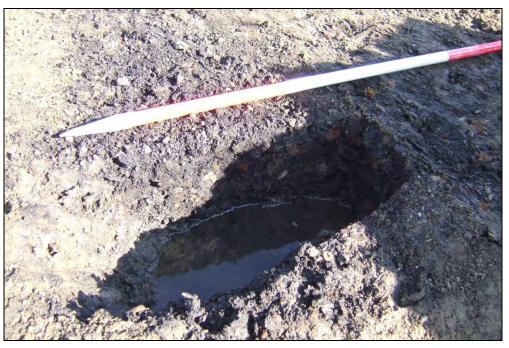
2.5m north-south x 2.5m east-west) was noted
				110m from the southern end of the trench
				Additional trenches TT 13 and TT 14 were
				excavated around this feature to determine its ful
				extent. The burnt mound, designated as Ballymur
				3, measured at least 0.33m in depth as established
				through a section excavated through the feature
				(Plates 2 and 3). It is possible that a trough feature
				is present under the mound (in the location of the
				section) however this was not confirmed during
				testing. A greyish clay deposit (C81) measuring c
				3m southeast-northwest and 2m southwest-
				northeast, overlay the burnt mound spread possibly
				obscuring the full extent of C26 however it is likely
				that C26 and C81 are directly related and the ful
				extent of the burnt mound is calculated as 3m north-
				south and 3m east-west.
				Field boundary ditch C7 continued through this

A single site of archaeological significance (Ballymun 3) was identified *c*. 110m from the south of TT 8 in TA A1 (Plates 2 and 3). Two offset trenches (TT 13 and TT 14) were excavated to the east of TT 8 in order to identify the full extent of the site; however the site did not extend into TT 14. Ballymun 3 comprises the flattened remains of a burnt moundmeasuring 3m north–south, 3m east–west and at least 0.33m in depth. It is possible that a trough feature is present under the mound (in the location of the section) however this was not confirmed during testing.

Plate 3: Ballymun 3, section through burnt mound C26, facing north

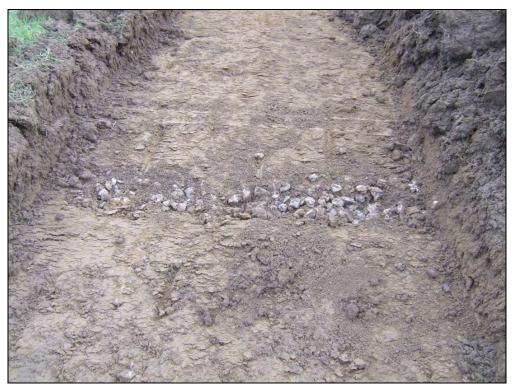
Plate 5: Modern field drain C6 in TT 1 (TA A1), facing north

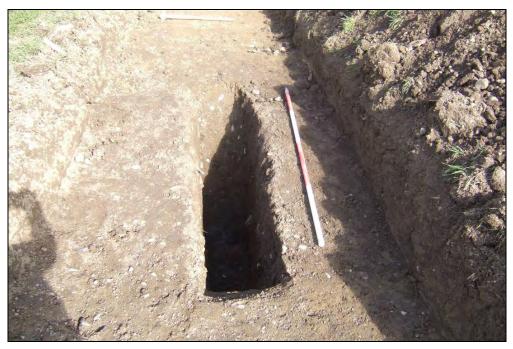
trench and was located c. 38.5m from the southern
				end of TT 8 (Plate 6). A section excavated through
				the ditch in this trench found the ditch to be c. 2.3m
				wide and 1m deep. In addition to this stone-filled
				drain C6 was located c. 25m from southern end of
				trench and an agricultural furrow (C27) ran along
				western edge of the trench.
TT 9	356m	1.8m	0.3m	A non-archaeological spread of greyish/black silty
				clay (C28) was noted midway along TT 9. Boundary
				ditch C7 was again recorded in southern end of the
				trench. Three northeast to southwest paralle

Plate 6: Boundary ditch C7 in TT 8 (TA A1), facing north

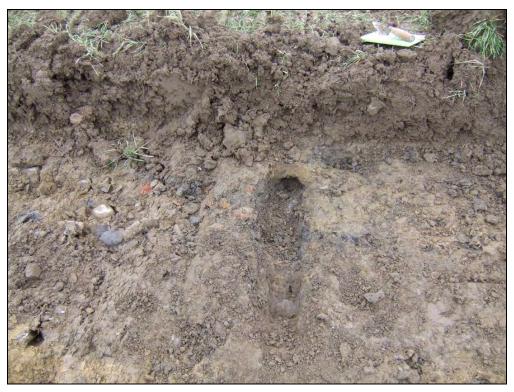
Plate 7: Field clearance burning C20 in TT 5 (TA A1), facing east

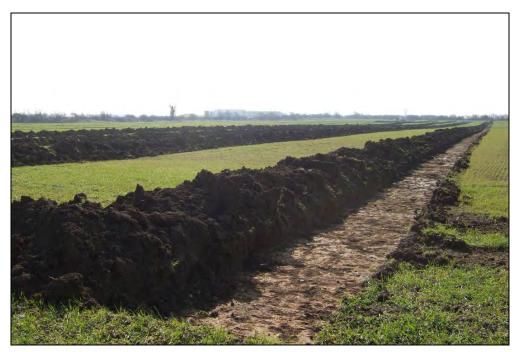
Plate 8: TT 12 and TT 11 in TA A1, facing southeast

Trench No:	Length	Width	Depth	Description/Archaeological Features
				furrows (C29, C30 and C31) were recorded intermittently throughout the trench. No features of archaeological significance were noted in TT 9.
TT 10	351m	1.8m	0.3m	Drain C10 was noted in the northern end of the trench. Three northeast to southwest parallel furrows (C32, C33 and C34) were recorded intermittently throughout the trench. No features of archaeological significance were noted in TT 10.
ΤΤ 11	347m	1.8m	0.35m	Drains C10 and C15 were located in the northern end of the trench. Boundary ditch C7 traversed the southern end of the trench. No features of archaeological significance were noted in TT 11.
TT 12	340m	1.8m	0.4m	Two northeast to southwest parallel furrows (C35 and C36) were recorded intermittently throughout the trench. Drain C15 was also noted in the northern end of the trench. Boundary ditch C7 again continued through this trench. No features of archaeological significance were noted in TT 12 (Plate 8).

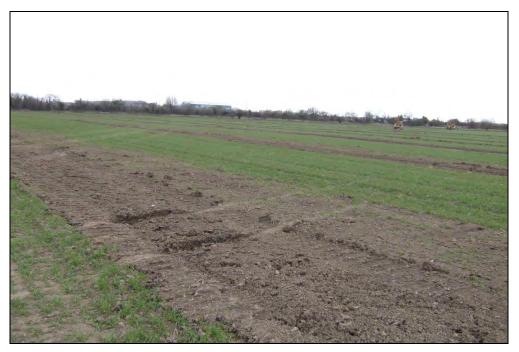
Plate 9: TA A2, following testing, facing northeast

Test Area A2 (TA A2) is located to the east of TA A1 and measured approximately 53,422 square meters (Figure 2, Plates 9–13). Test Area A2 (TA A2) comprised a large open tillage field. A total of 16 trenches, measuring 3,530 linear meters were excavated in TA A2.

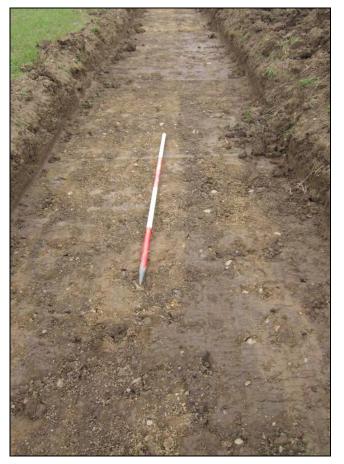
Plate 10: Furrow C38 in TT 8 (TA A2), facing north

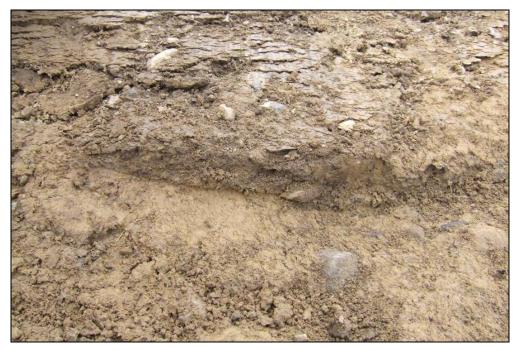
Plate 11: Section through furrow C38 in TT 8 (TA A2), facing south

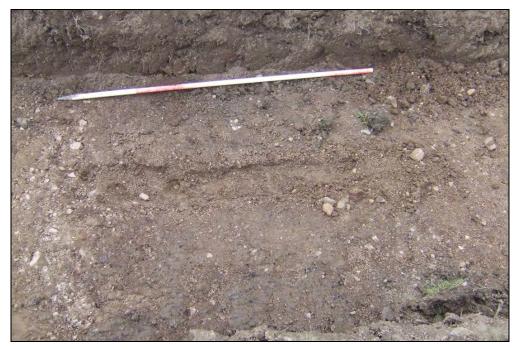
Plate 12: Section through boundary ditch C43 in TT 16 (TA A2), facing west

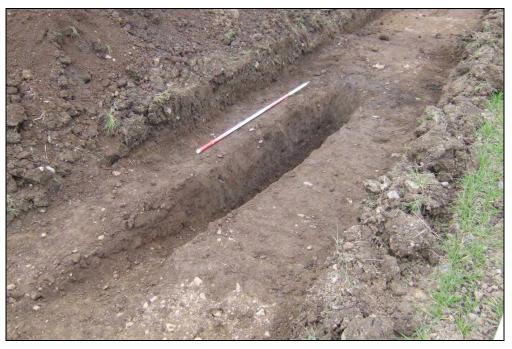
Trench No:	Length	Width	Depth	Description/Archaeological Features	
				identified in TT 15.	
ΤΤ 16	348m	1.8m	0.35m	A possible boundary ditch (C44) was noted in the southern limit of TT 16 (Plate 13). Although large (6m wide and 0.8m deep – established through test section) it was not noted in any other trenches. It is possible that this ditch is related to the extant field boundary immediately to the west of TT 16. A second field boundary (C43) was noted to the north of this (Plate 12) and was disturbed by two large patches of a modern bonfire/dump (C54 and C55). Four east–west drains were noted throughout the length of the trench (C42, C48, C53 and C56). No features of archaeological significance were identified in TT 16.

Plate 13: Section through boundary ditch C44 in TT 16 (TA A2), facing west

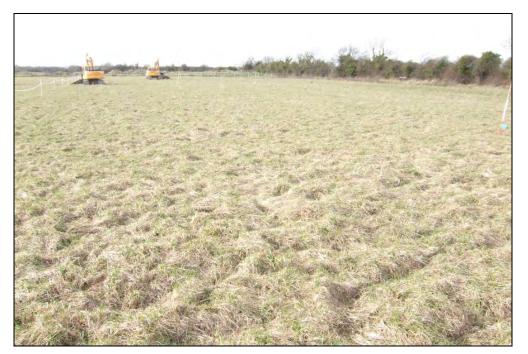
Plate 14: TA A3, prior to testing, facing west

Test Area A3 (TA A3) is located to the east of TA A2 and measured approximately 5,763 square meters (Figure 2; Plates 14–17). Test Area A3 (TA A3) comprised a small sized field of pasture. A total of 4 trenches, measuring 382 linear meters were excavated in TA A3.

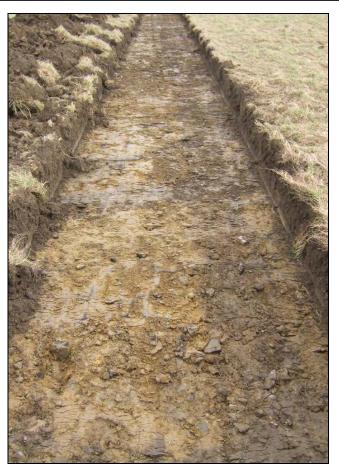
Plate 15: Drain C57 in TT 2 (TA A3), facing east

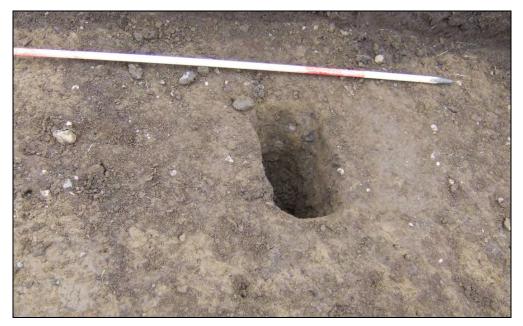
Plate 16: Section through drain C57 in TT 2 (TA A3), facing north

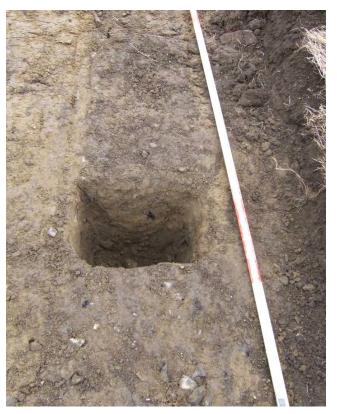
C58	ТА АЗ	TT 3	Modern drain	A linear drain was noted running along the southern edge of TT 3 (parallel to C57), measuring <i>c</i> . >115m long x 0.51m wide x 0.56m deep. The drain was a straight sided linear cut with a flat base, filled with a mottled mid to dark grey and yellowy-brown compact silty clay redeposit subsoil, increasing stone content near the base, with inclusions of 19th and 20th century finds.	
C59	TA A3	TT 2–4	Agricultural furrow	North to south oriented furrow ran along the eastern limit of TT2–4, measuring 0.5m wide and 0.07m deep. Some brick and animal bone were noted in the fill.	
C60	TA B1	TT 1	Agricultural furrow	South southwest to north northeast oriented truncated furrow, measuring <i>c</i> . 0.3m wide x 0.02m deep, <i>c</i> . 30m from north end of trench.	
C61	TA B1	TT 1	Agricultural furrow	South southwest to north northeast oriented truncated furrow, measuring c. 0.2m wide x

Plate 17: Section through drain C58 in TT 3 (TA A3), facing east

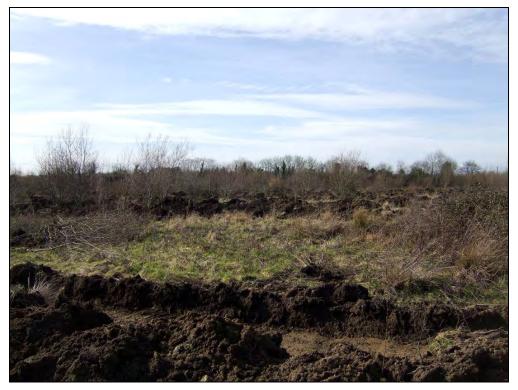
Plate 18: TA B1, following testing, facing west

Test Area B1 (TA B1) is located to the northeast of TA A2 and measured approximately 19,517 square meters (Figure 2; Plates 18–20). Test Area B1 (TA B1) comprised an area planted with tree saplings. A total of 12 trenches, measuring 1,285 linear meters were excavated in TA B1.

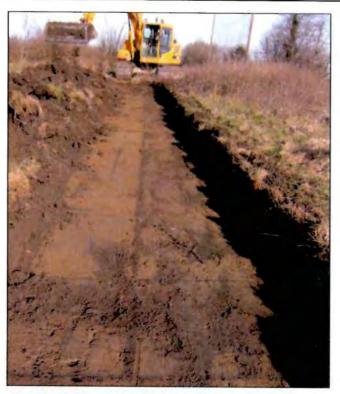
Trench No:	Length	Width	Depth	Description/Archaeological Features
Π-1	140m	1.8m	0.4m	Two furrows (C60 and C61) crossed the trench at <i>c</i> . 30m and <i>c</i> . 60m from the north end of the trench (Plate 19). No features of archaeological significance were identified in TT 1.
TT 2	135m	1.8m	0.4m	Nothing of archaeological significance was noted at the location where geophysical anomaly (8) was identified. A single furrow (C62) ran intermittently for the length of the trench. No features of archaeological significance were identified in TT 2. Anomaly (8) identified by the geophysical survey was located within this trench, but was not identified by the testing programme.
Π3	130m	1.8m	0.35m	A single furrow (C63) ran intermittently for the length of the trench. No features of archaeological significance were identified in TT 3.
TT 4	125m	1.8m	0.35m	A probable field boundary ditch (C64; Plate 20) was identified running roughly east to west which corresponds to the linear geophysical anomaly (7). The ditch seems to have been heavily truncated as it was quite shallow (1.2m wide, 0.07m deep) in TT 4. This boundary ditch was not identified in TT 1–3.

Plate 19: Furrow C60 in TT 1 (TA B1), facing north

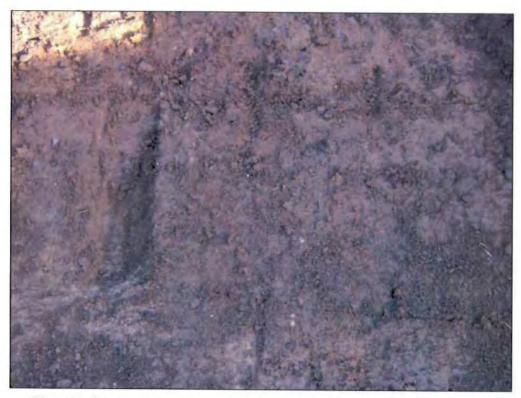
ΤΤ 9	100m	1.8m	0.35m	Probable field boundary C64 was noted in the trench as a band of stones, <i>c</i> . 38m from the north of the trench. A second east–west possible boundary ditch (C70) was noted <i>c</i> . 33m from the north end of the trench. No features of archaeological significance were identified in TT 9.
TT 10	90m	1.8m	0.3m	A single furrow (C71) ran intermittently for the length of the trench. No features of archaeological significance were identified in TT 10.
TT 11	90m	1.8m	0.35m	A single furrow (C72) ran intermittently for the length of the trench.

Plate 20: Section through boundary ditch C64 in TT 9 (TA B1), facing north

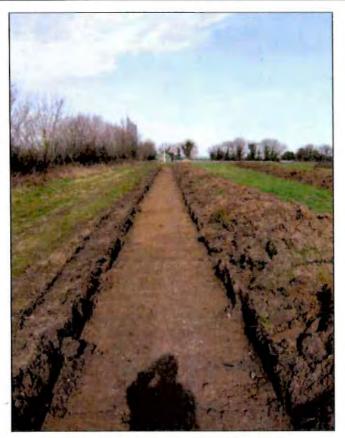
Plate 21: TT 1 in TA B2, facing north

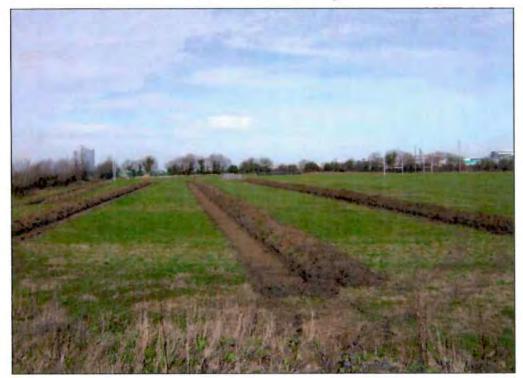
Plate 22: TA B2, following testing, facing north

Test Area B2 (TA B2) is located to the east of TA B1 and measured approximately 27,488 square meters (Plates 21–22). TA B2 partly comprised two GAA playing fields. It was originally intended to test the entire test area, including the GAA pitches; however it was subsequently decided, through consultation between the RPA and GAA representatives, not to test the playing pitches at this time.
